# Sochacki Park Monitoring Data Summary 2021

## Sub-watershed Assessment

# Sochacki Park Sub-watershed Assessment

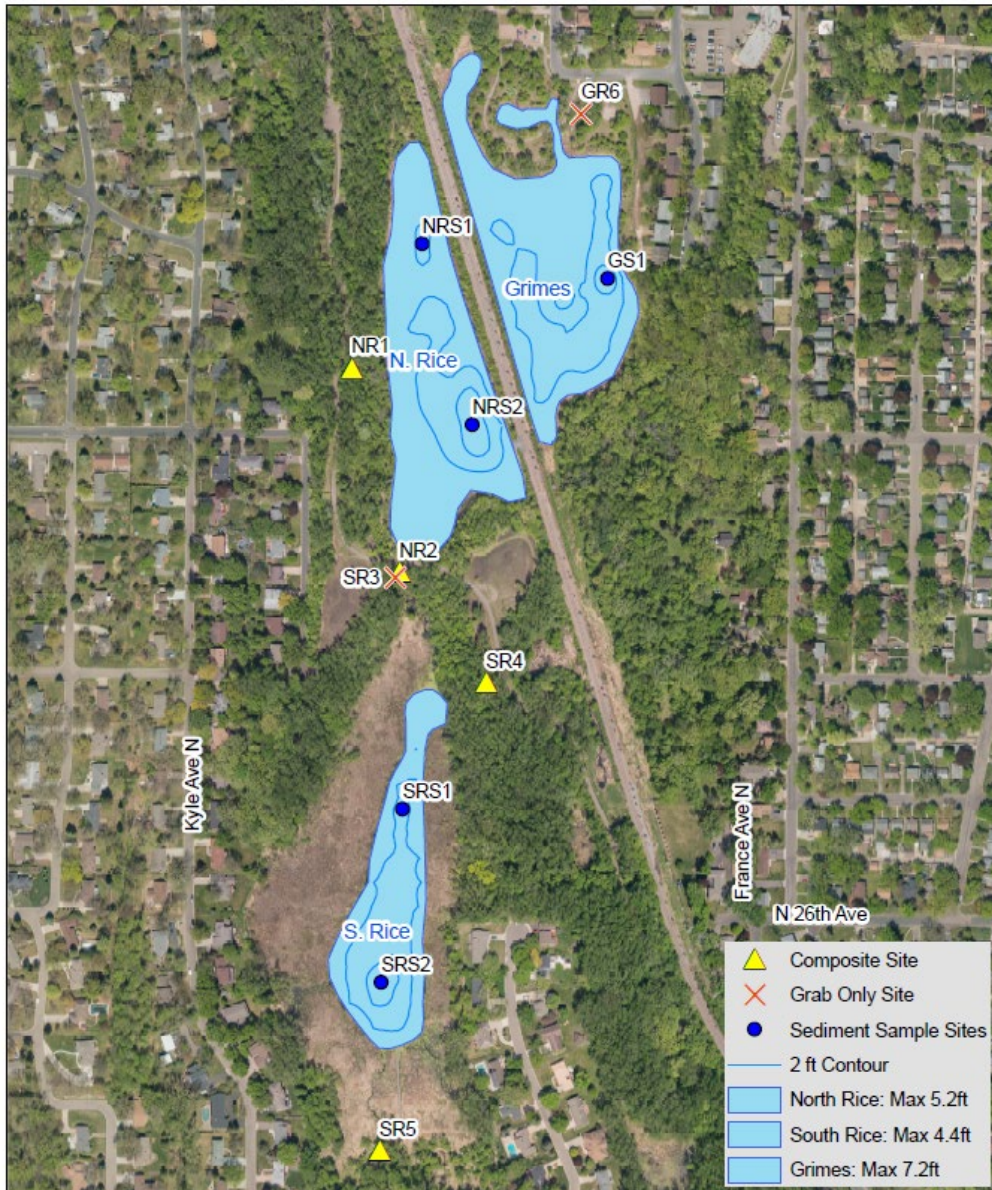
## Sochacki Park Ponds

- 3 wetlands–water quality
  - Grimes
  - North Rice
  - South Rice
- 4 stormwater monitoring sites
- 2 sites where grab water samples were collected during storm events
- 5 sediment core locations

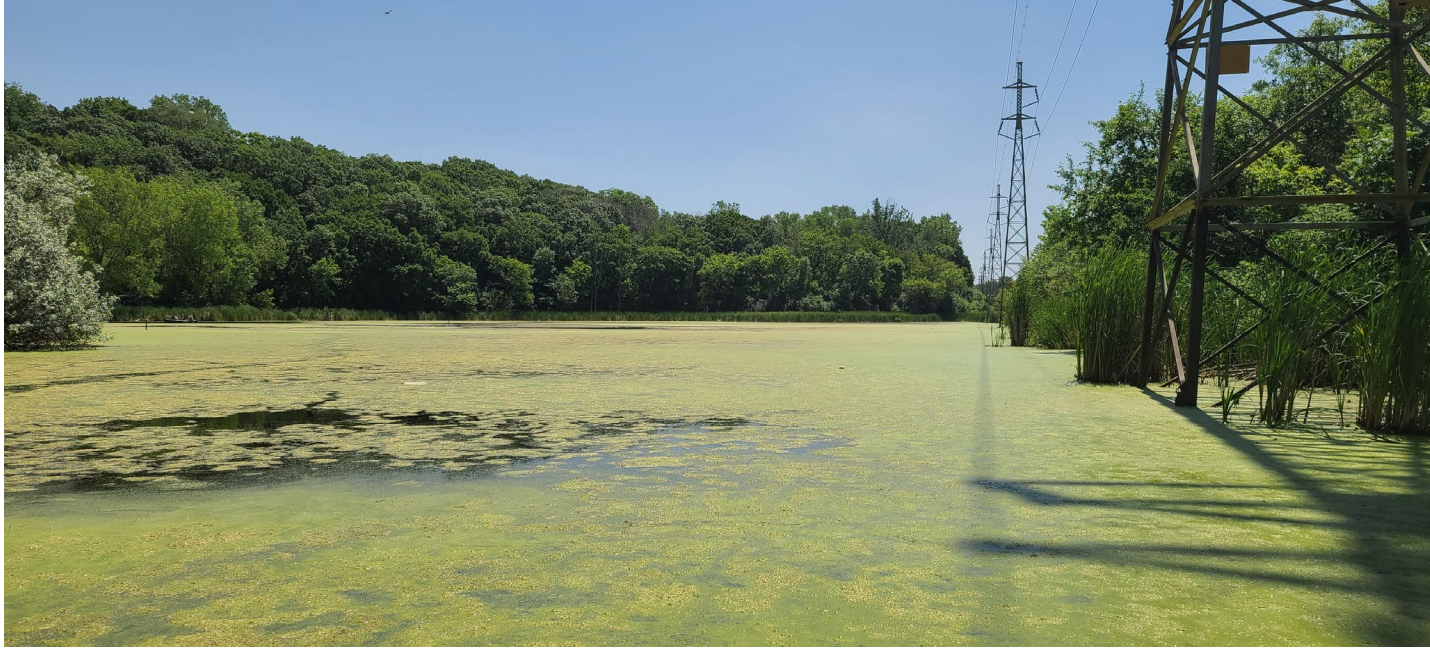
# Grimes Pond

- A culvert that flows into Grimes, GR6, stormwater
  - Flow only during storm events
    - 2 grab samples collected in 2020
    - 1 grab sample collected in 2021
  - Had highest TP and TN concentrations of all stormwater sites

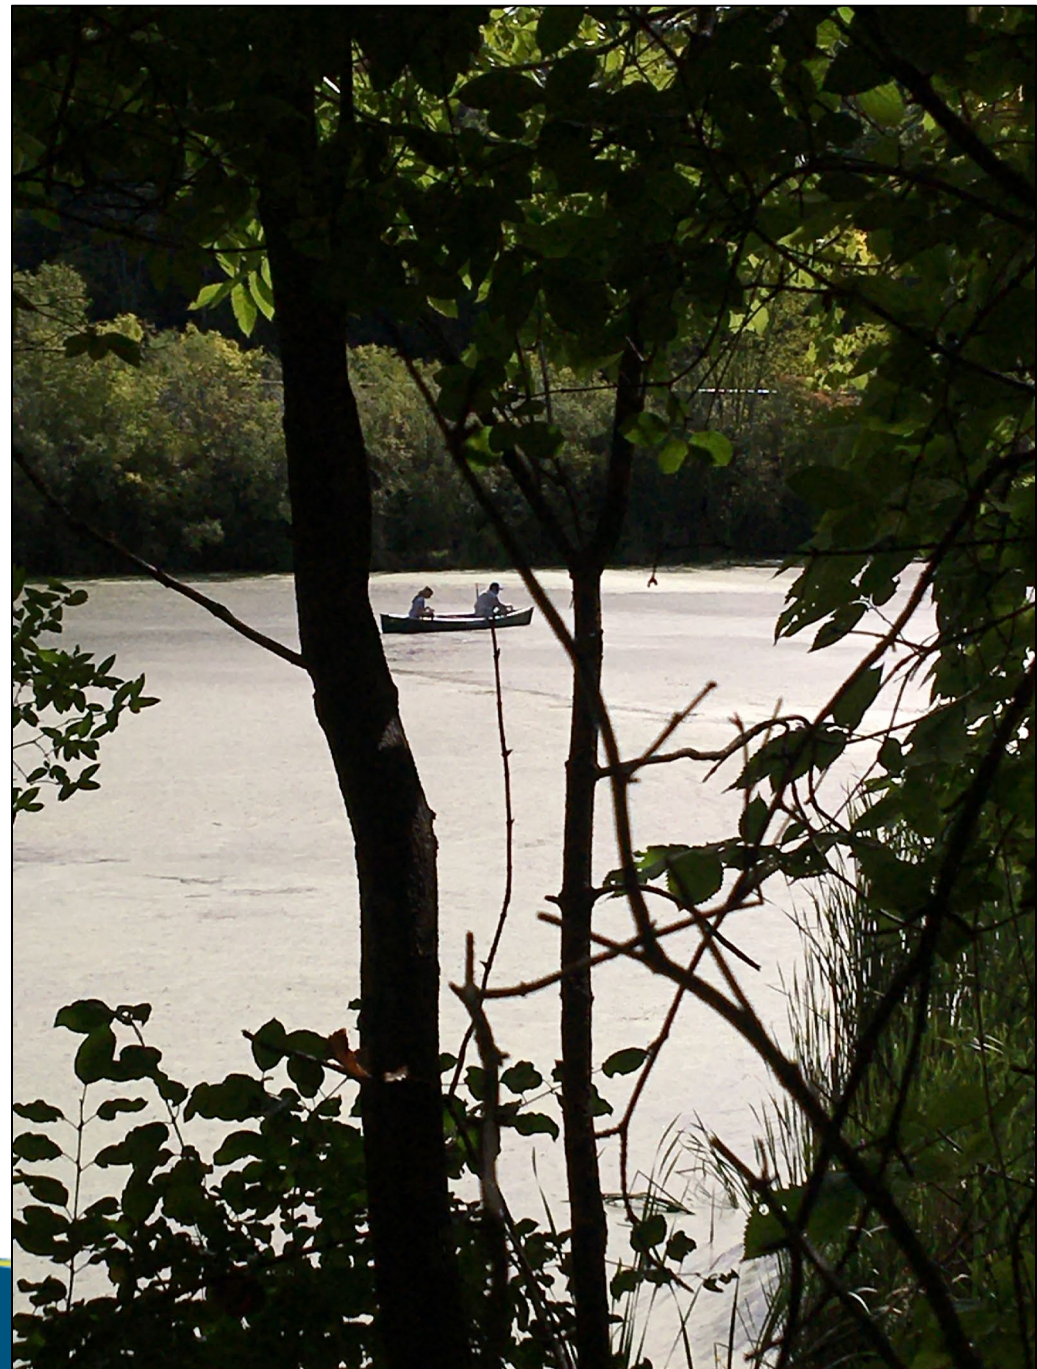
# North Rice Pond

- Receives water from Grimes and NR1
  - There may be other smaller channels – but NR1 is the primary input

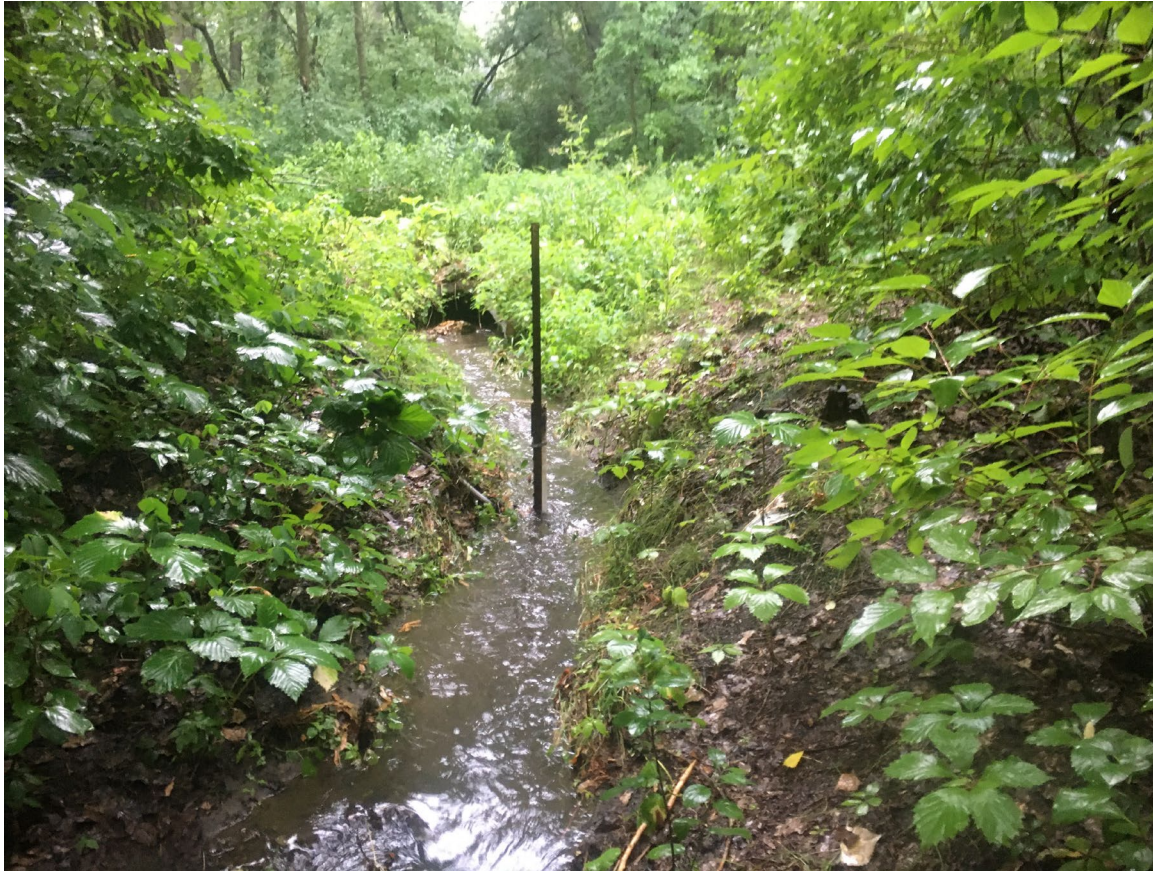
# NR1 – North Rice Site 1

- Flow only during rain events
  - Sandy soils, so water infiltrates
- Very little flow into North Rice pond
  - Therefore, less loading than other sites
- Yearly loading:
  - 2021 had higher concentrations and higher loading even though a little less precipitation
  - Collected similar number of samples each year

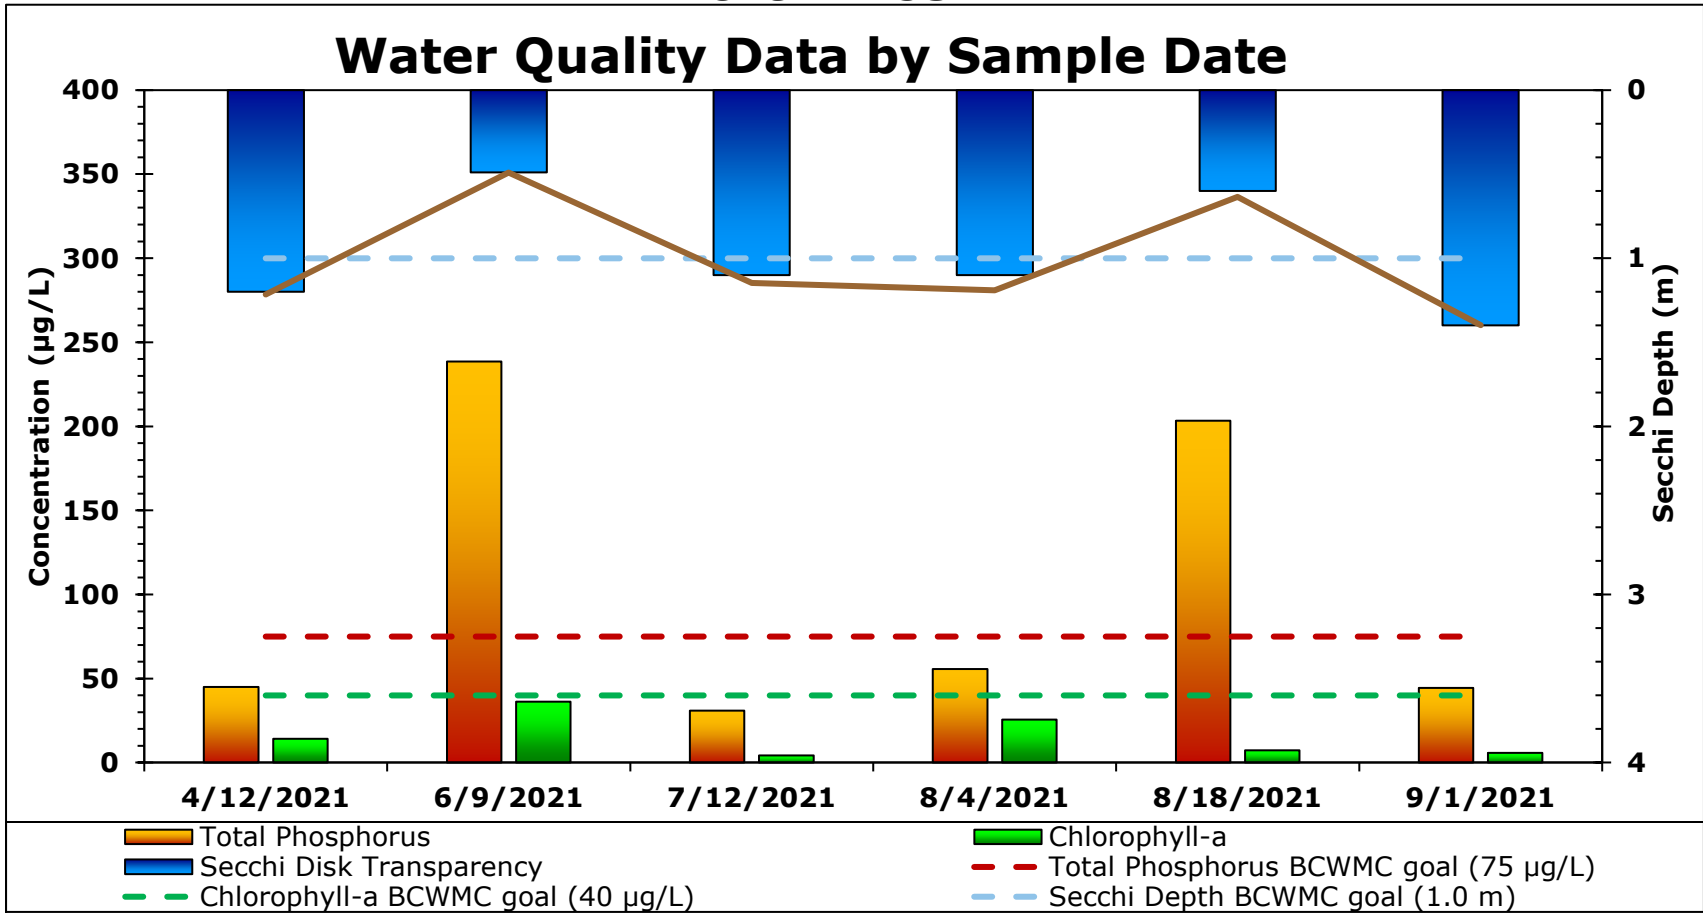
# North Rice

- 2 sample events taken in more shallow areas
  - To ensure a better sample, locations with less vegetation are chosen
  - Those samples happen to have highest TP concentrations
- Meeting Chlorophyll-a goals
- Meeting secchi depth goals (max reading = 1.4 m)
  - Pond is shallow and staff could see bottom of pond at every visit.

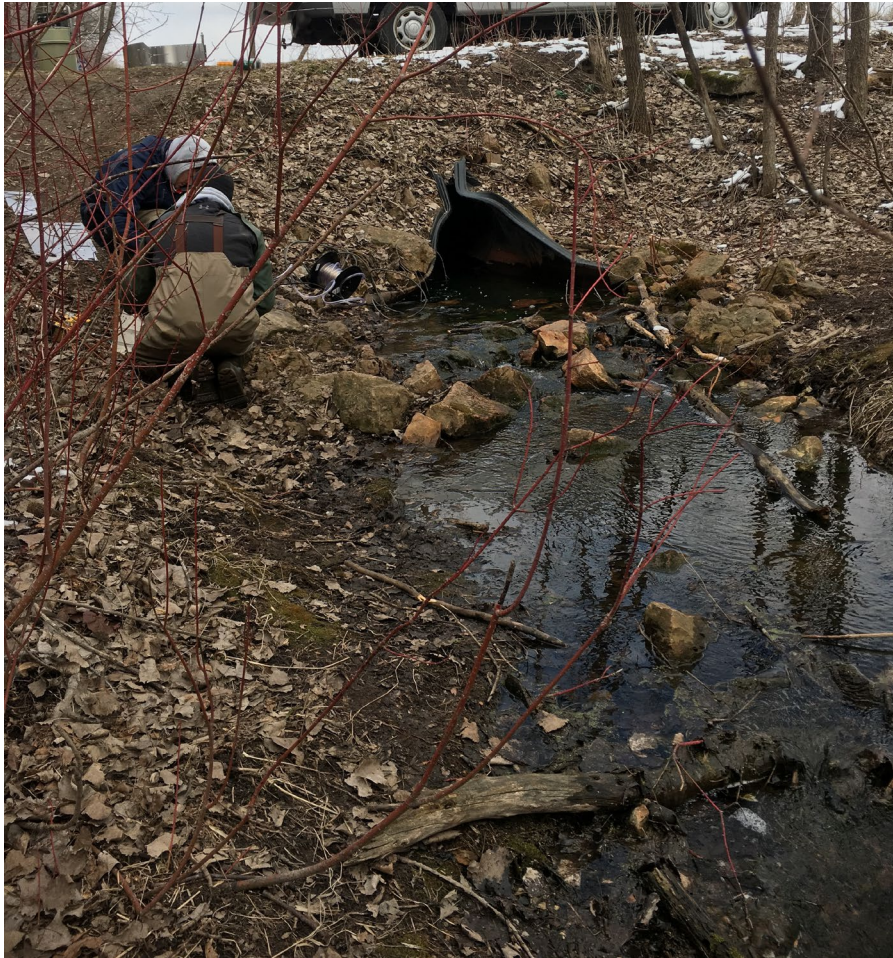
# NR2 – North Rice outlet

- Flows out of North Rice and into South Rice
- Lowest TP, TN and TSS concentrations of the sites
  - Has highest chloride concentrations
- Highest flow of sites
- Has average nutrient loading and high chloride loading compared to other sites
- Collected similar number of samples between 2020 and 2021

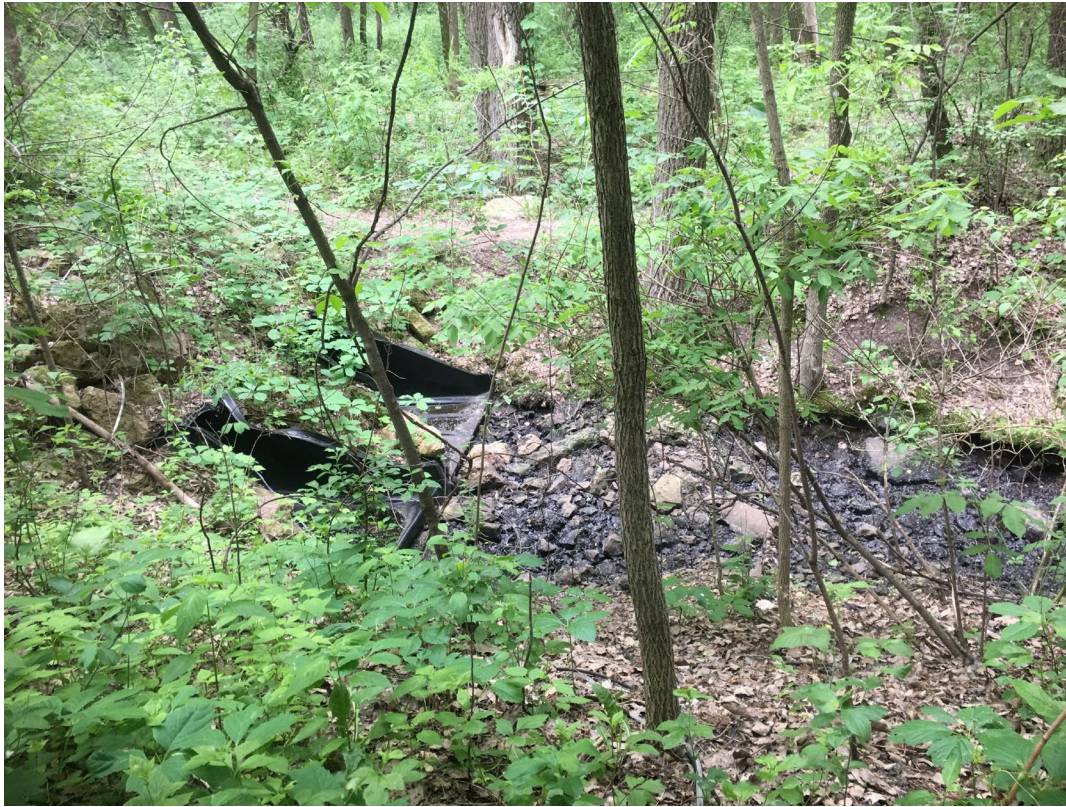
# SR4 – South Rice site 4

Double culvert that is dry until rain events

- Flows into South Rice
- Low flow since only during storm events
- Collected less samples in 2021 compared to 2020
  - Equipment issues, but were able to collect grabs during peak flow for 4 events
- Average nutrient loading compared to other sites

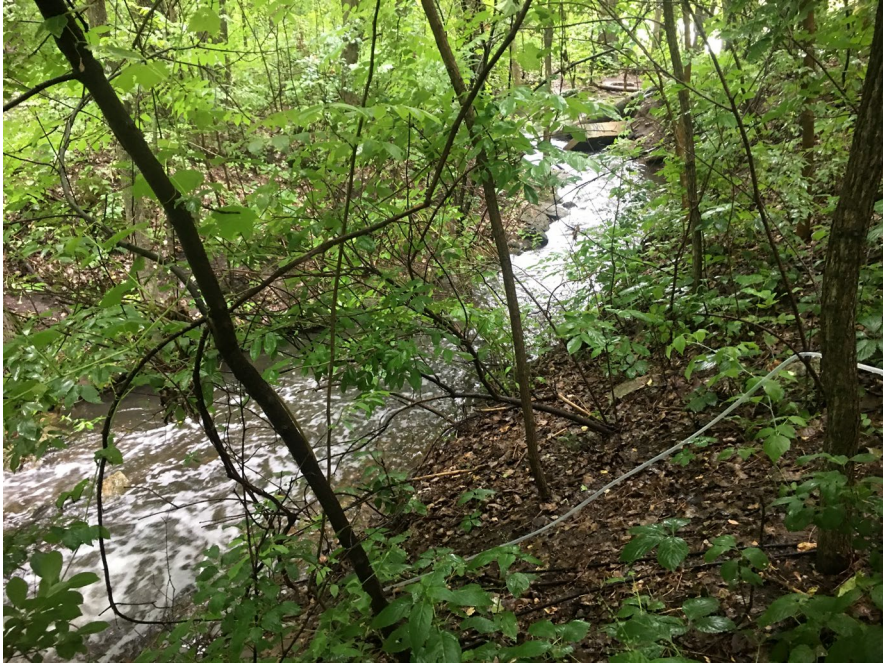
Downstream of site

- Quite a bit of concrete and building materials
- Channel is eroded due to heavy flow through this area

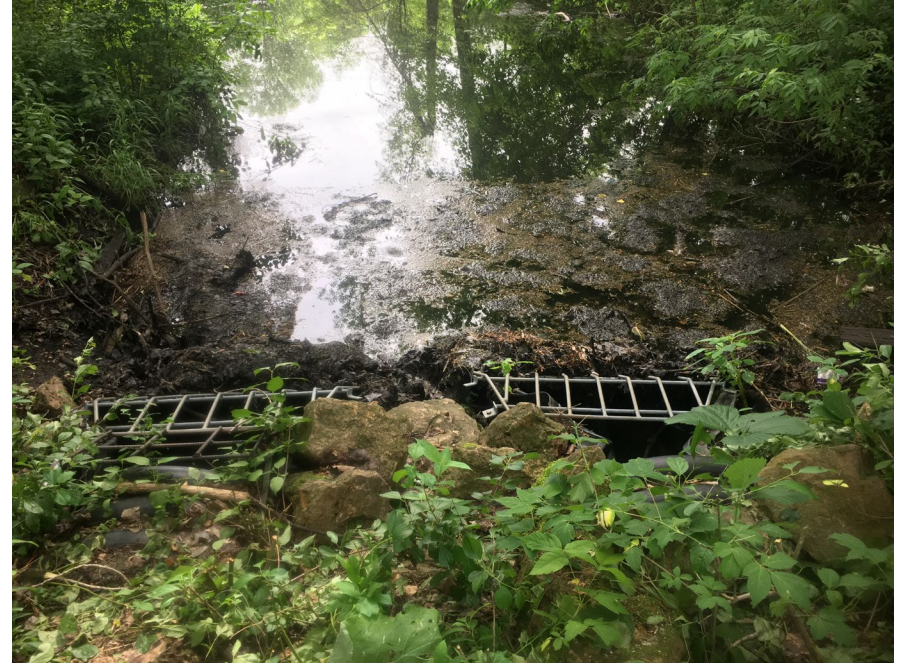
Upstream side of culvert

- Grates collect a lot of detritus/debris that is high in nutrients
- Cleaning this area out would allow the sediments to dry out

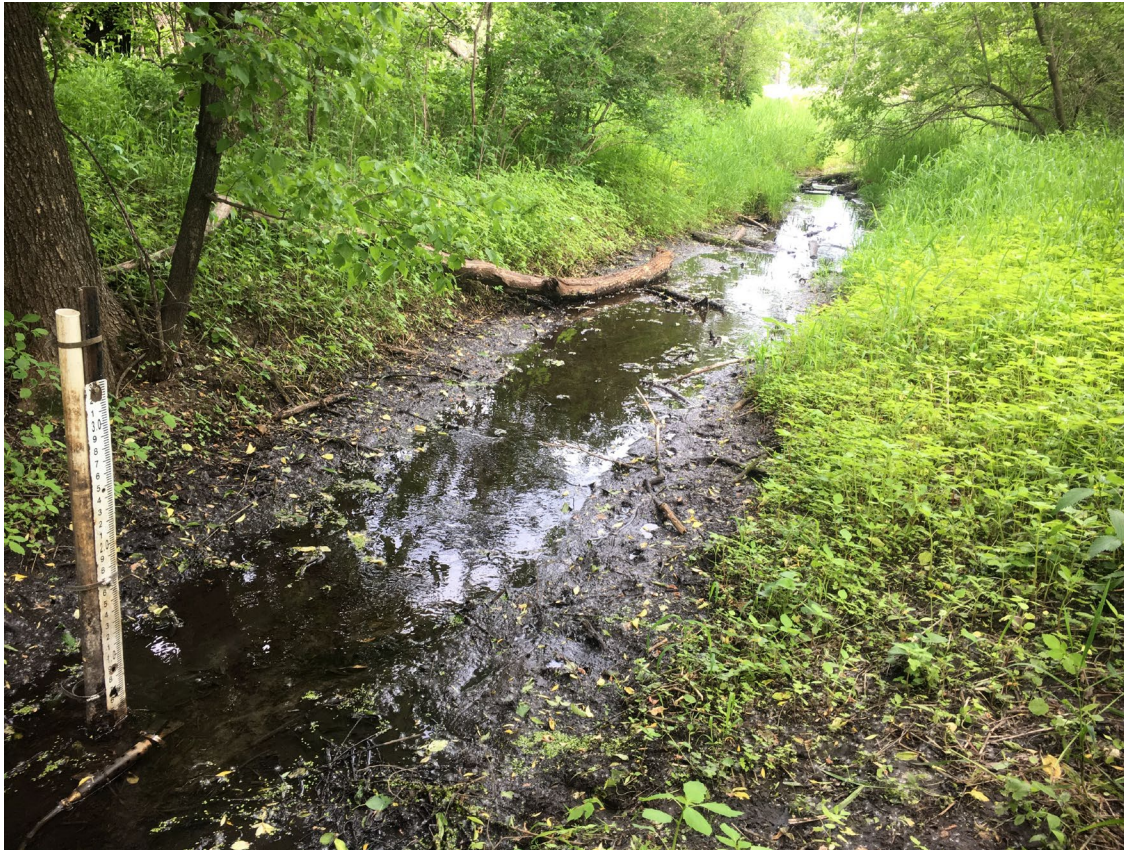
# SR5 – South Rice outlet

- Flows out of South Rice
  - There is a 2<sup>nd</sup> outlet channel with similar flows
- Average concentrations
- Measured flow is comparable to flow into South Rice
- Has similar loading to NR2 (outlet of North Rice) but highest TSS and CI loading of all the sites

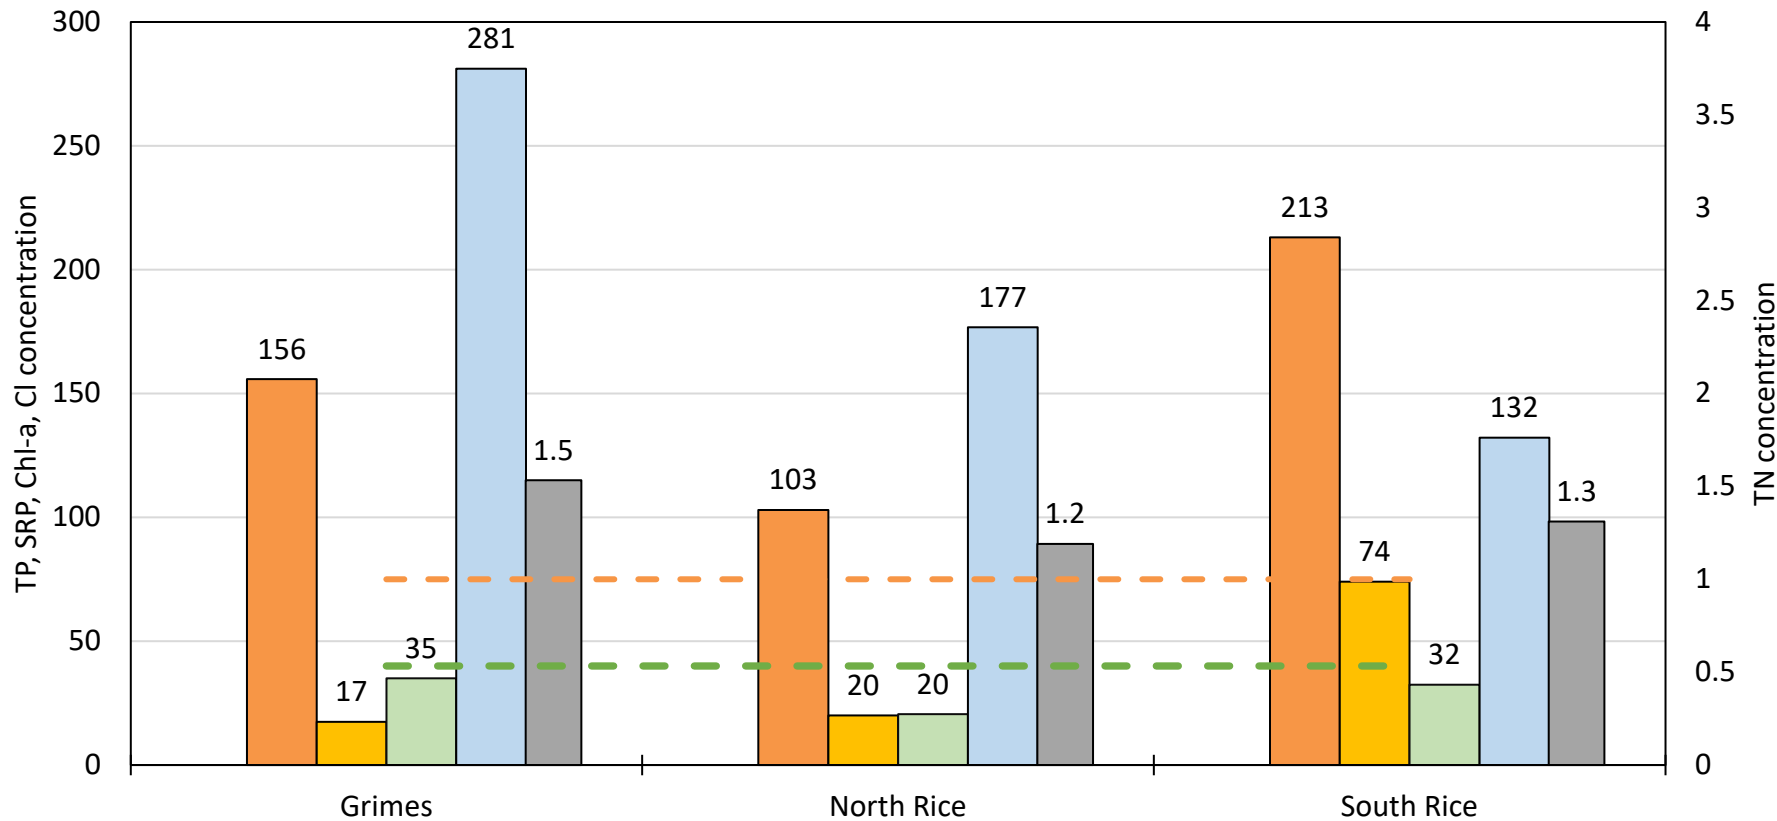
2021 lake data - Average concentrations – all samples

- Total Phosphorus (µg/L)
- Soluble Reactive Phosphorus (µg/L)
- Chlorophyll-a (µg/L)
- Chloride
- Total Nitrogen (mg/L)
- Total Phosphorus BCWMC goal (75 µg/L)
- Chlorophyll-a BCWMC goal (40 µg/L)
