# Sochacki Park Monitoring Data Summary 2020

# Sochacki Park

## Sub-watershed Assessment

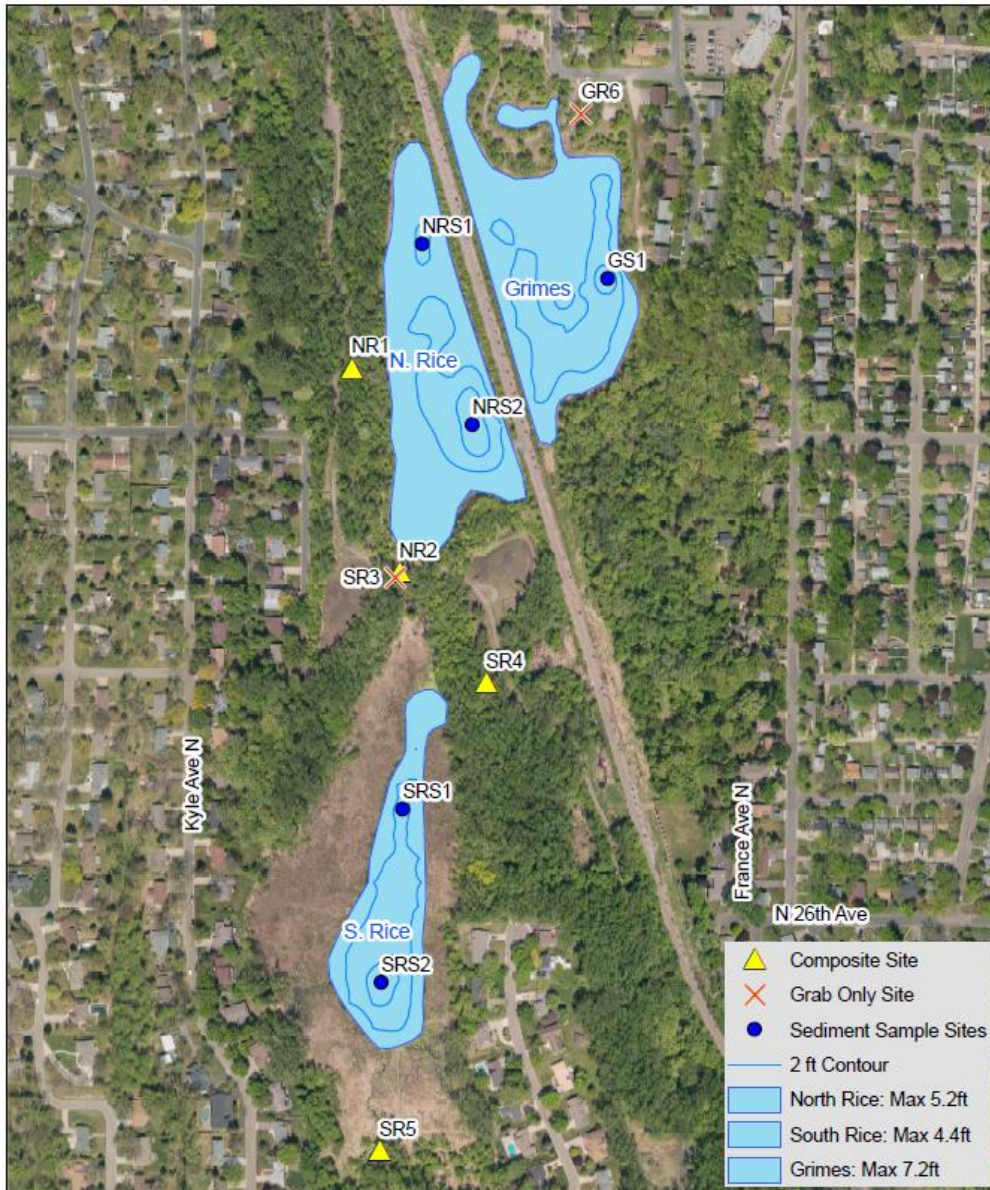
## Sochacki Park Ponds

- 3 wetlands–water quality
  - Grimes
  - North Rice
  - South Rice
- 4 stormwater monitoring sites
- 2 sites where grab water samples were collected during storm events
- 5 sediment core locations
- Preliminary Data 2021
  - Data presented on the following slides

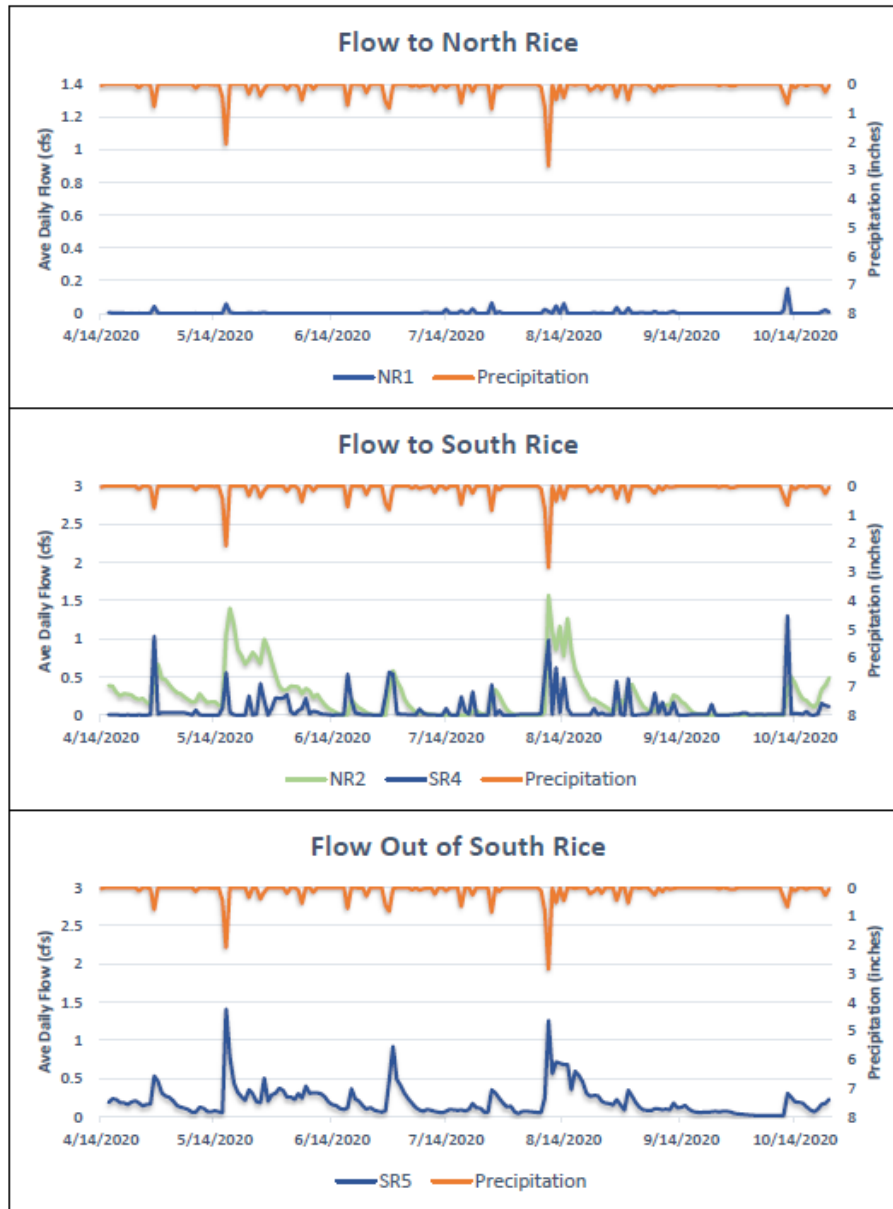
# Sochacki Park Precipitation and Flow 2020

- 2020 Calendar Year
  - Precipitation below average
  - 2020: 26 inches
  - 20-year average: 30 inches
- Notable Rain Events
  - May 16-17<sup>th</sup> – 2.53 inches
  - August 9-10<sup>th</sup> – 3.65 inches
  - The rain events account for 11% to 15% of the sampling site total flow volumes.
- Advantage of monitoring two years allows for variations in precipitation conditions.

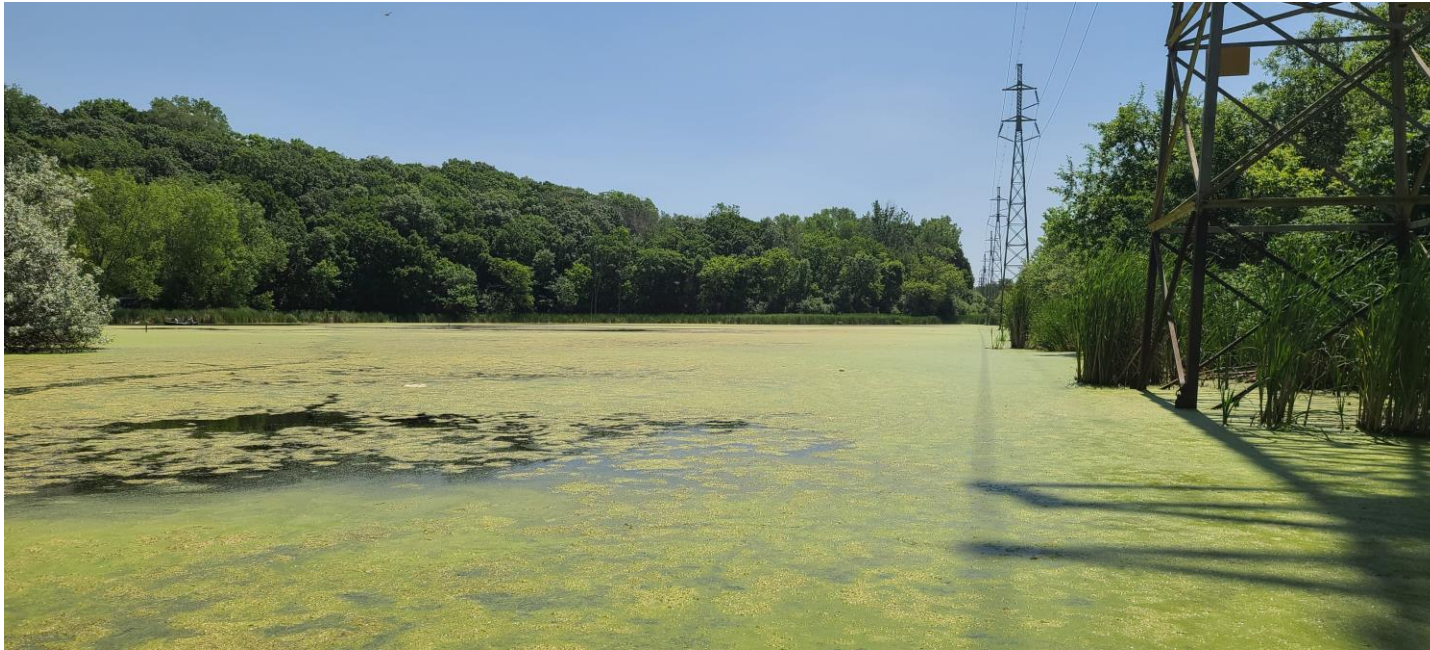
# Grimes Pond

- A culvert that flows into Grimes, GR6, seems to be main source of stormwater
  - Very little flow - only 2 grab samples collected

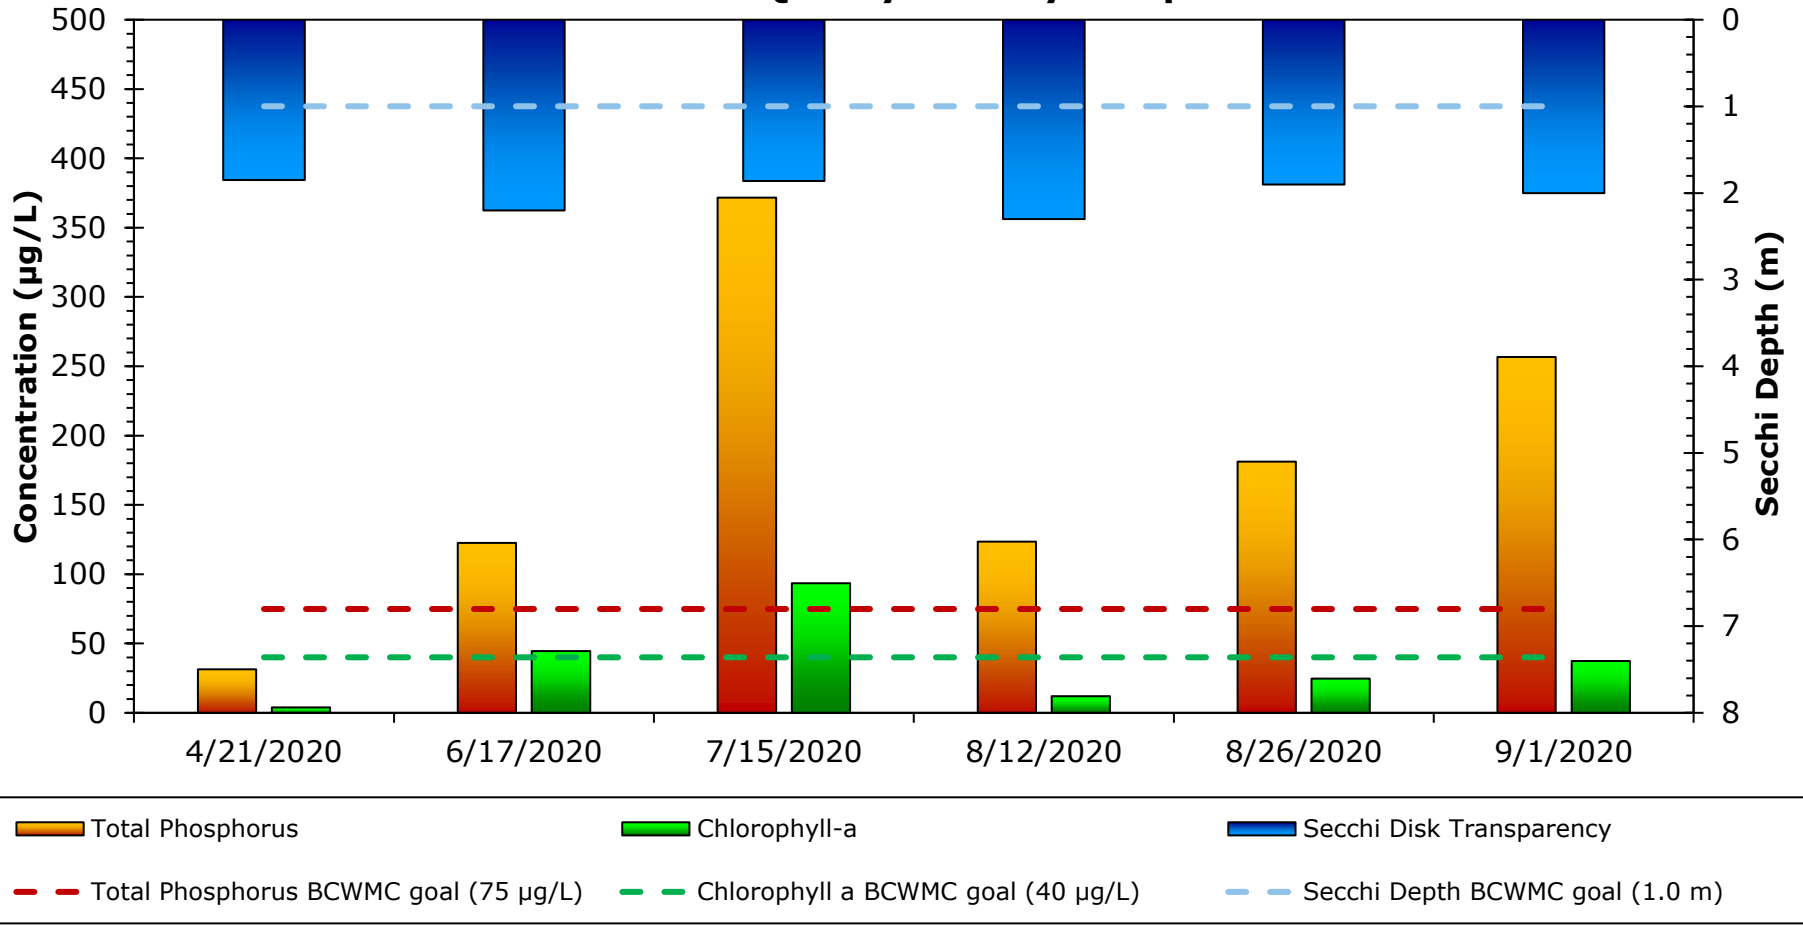
## Grimes Water Quality Data by Sample Date

- Not meeting TP goals most of season
- Meeting Chlorophyll-a goals most of season
- Meeting secchi depth goals (max depth = 2.19 m)

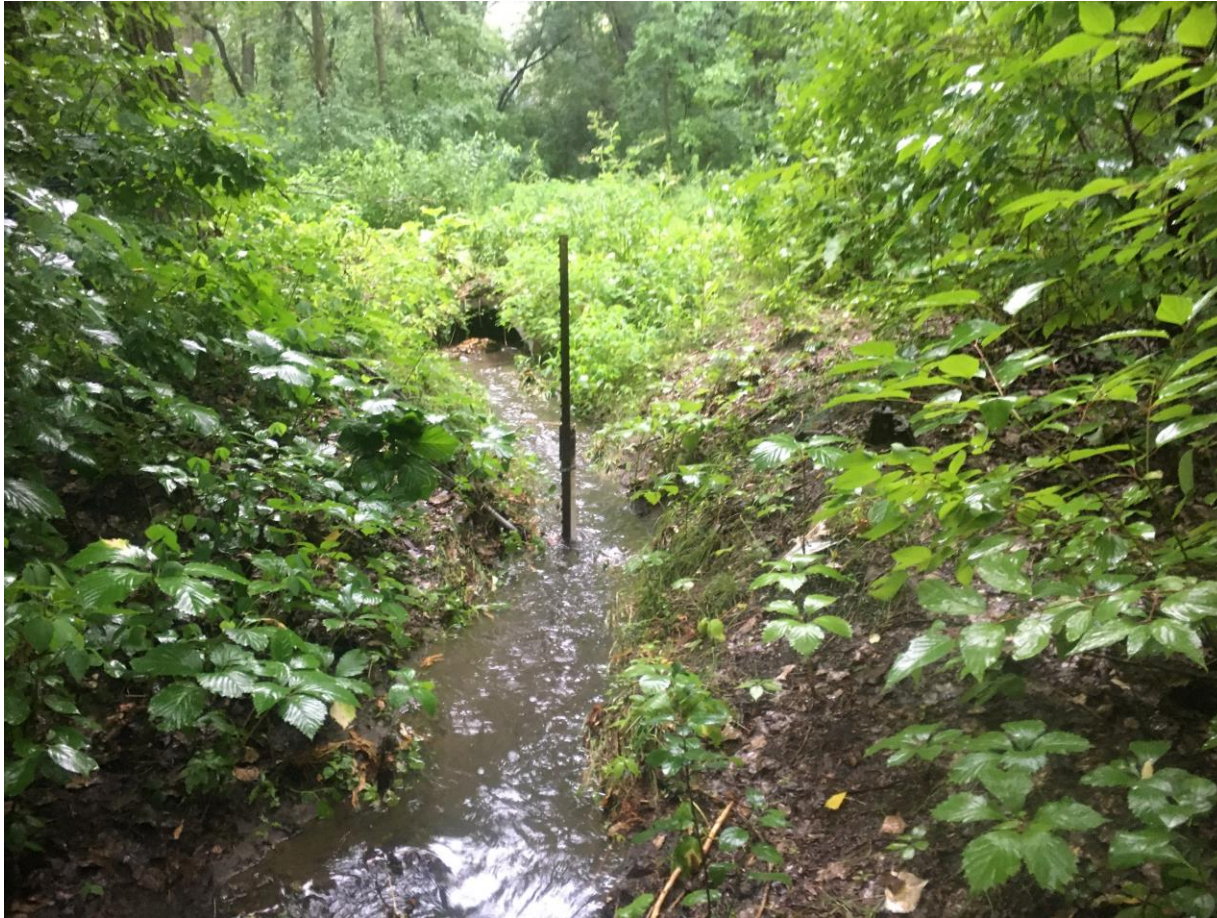
# NR1 – North Rice Site 1

- Only has flow during rain events
  - Sandy soils, so water infiltrates
- Very little flow into North Rice pond
  - $0.003 \times 10^6 \text{ m}^3$
- Low loading due to low flow even though has high concentrations
  - TP: 2 lbs/yr
  - TN: 12 lbs/yr
  - TSS: 283 lbs/yr
  - Chlorides: 0 lbs/yr

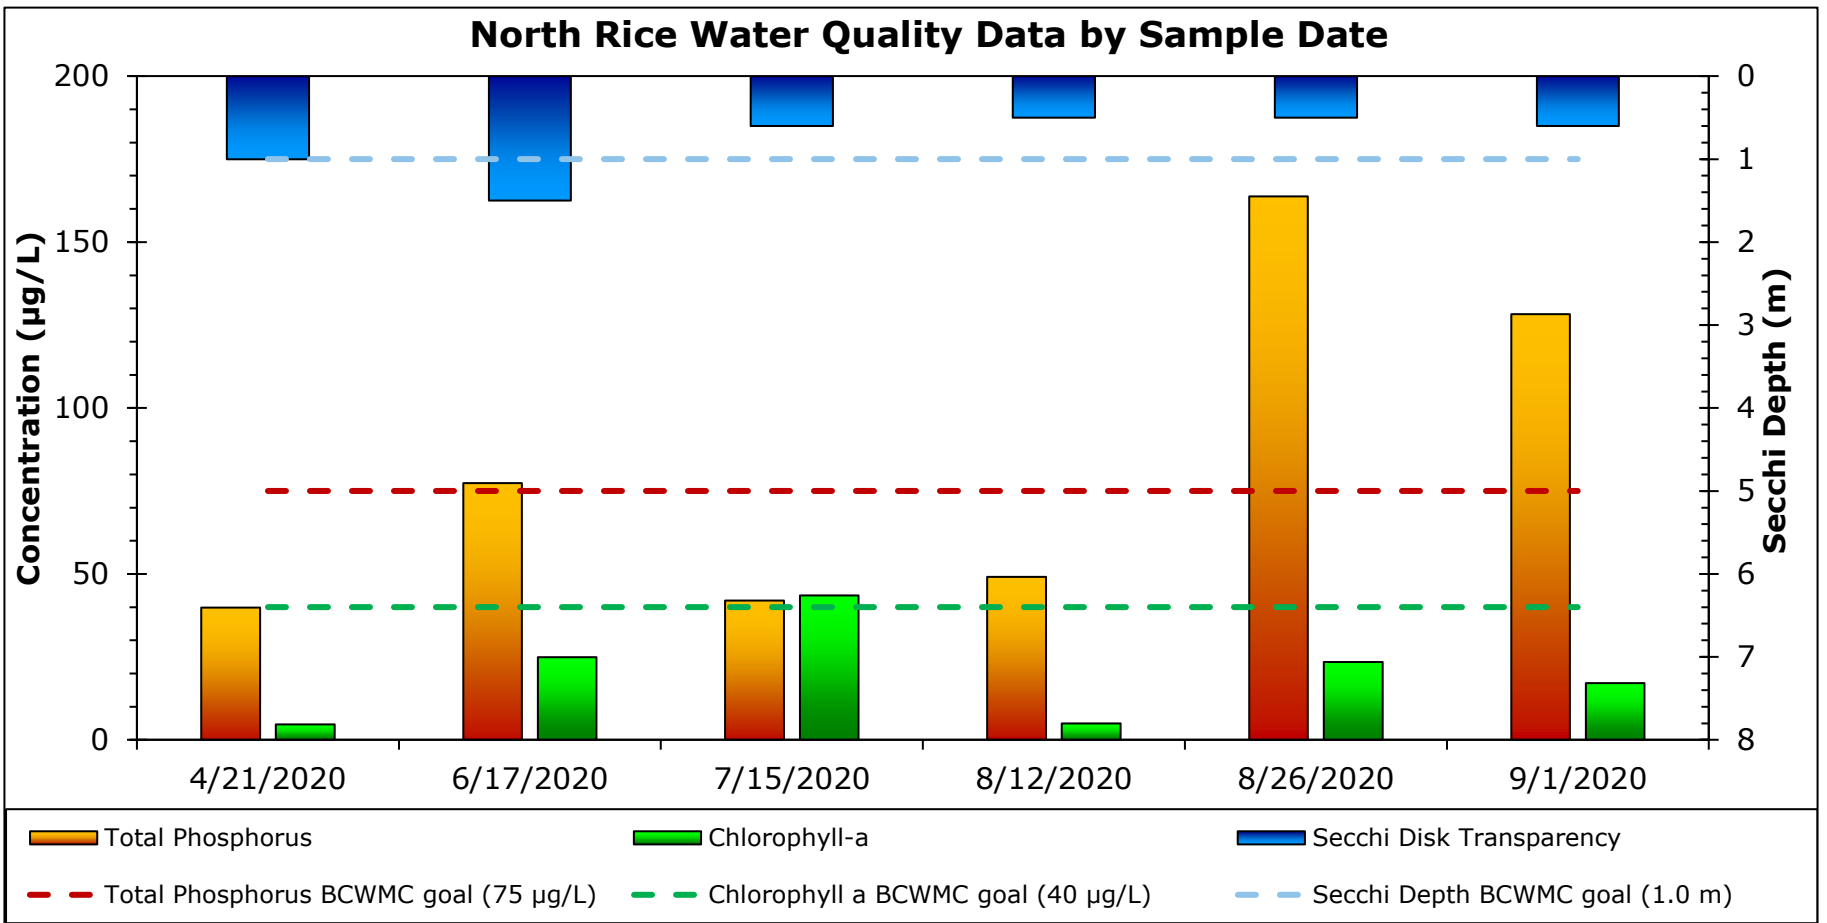
- Meeting TP goals until August
- Meeting Chlorophyll-a goals most of season
- Not meeting secchi depth goals (max depth = 1.58 m)
  - Pond is shallow and staff could see bottom of pond at every visit.

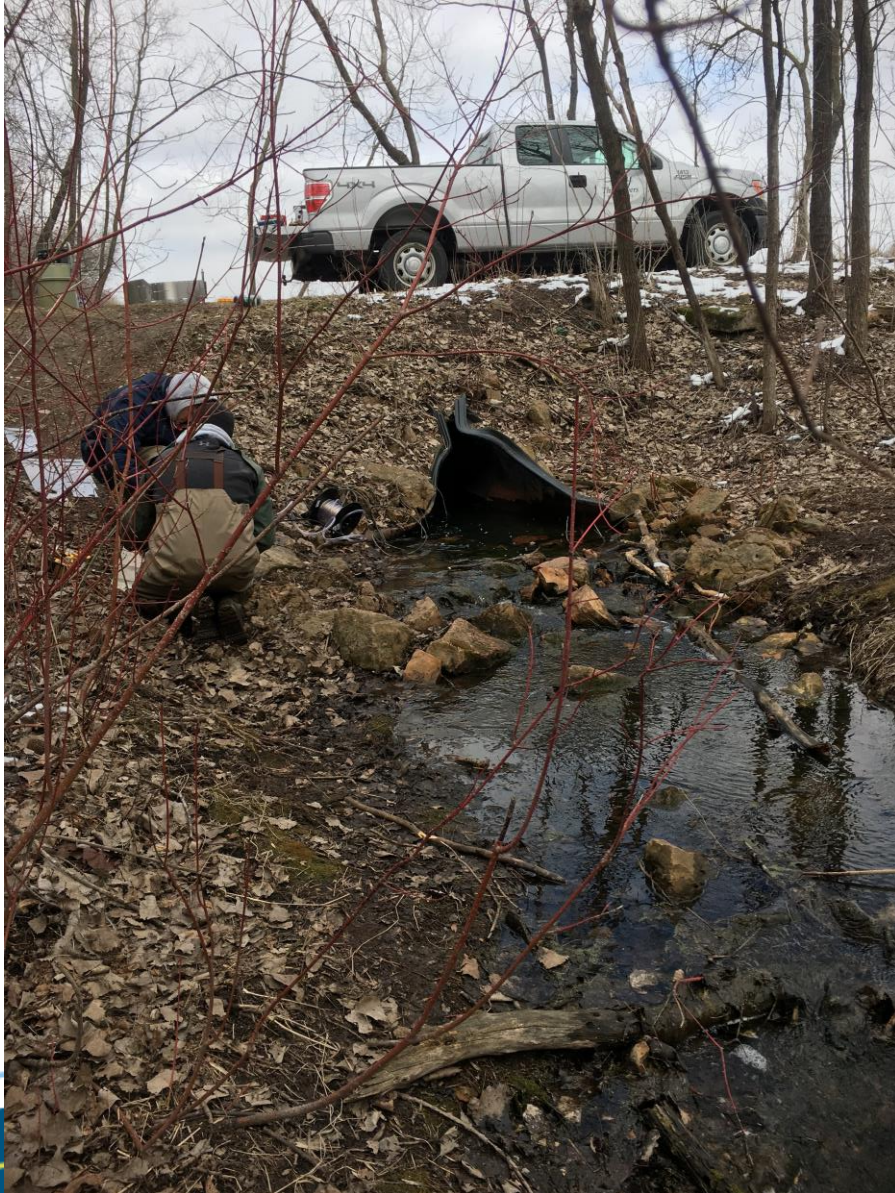
# NR2 – North Rice outlet

- Flows out of North Rice and into South Rice
- Lowest nutrient and TSS concentrations of the sites
  - Has highest chloride concentrations
- Highest flow of sites
  - $0.15 \times 10^6 \text{ m}^3$
- Has average nutrient loading and high chloride loading
  - TP: 50 lbs/yr
  - TN: 459 lbs/yr
  - TSS: 1,900 lbs/yr
  - Chlorides: 45,700 lbs/yr

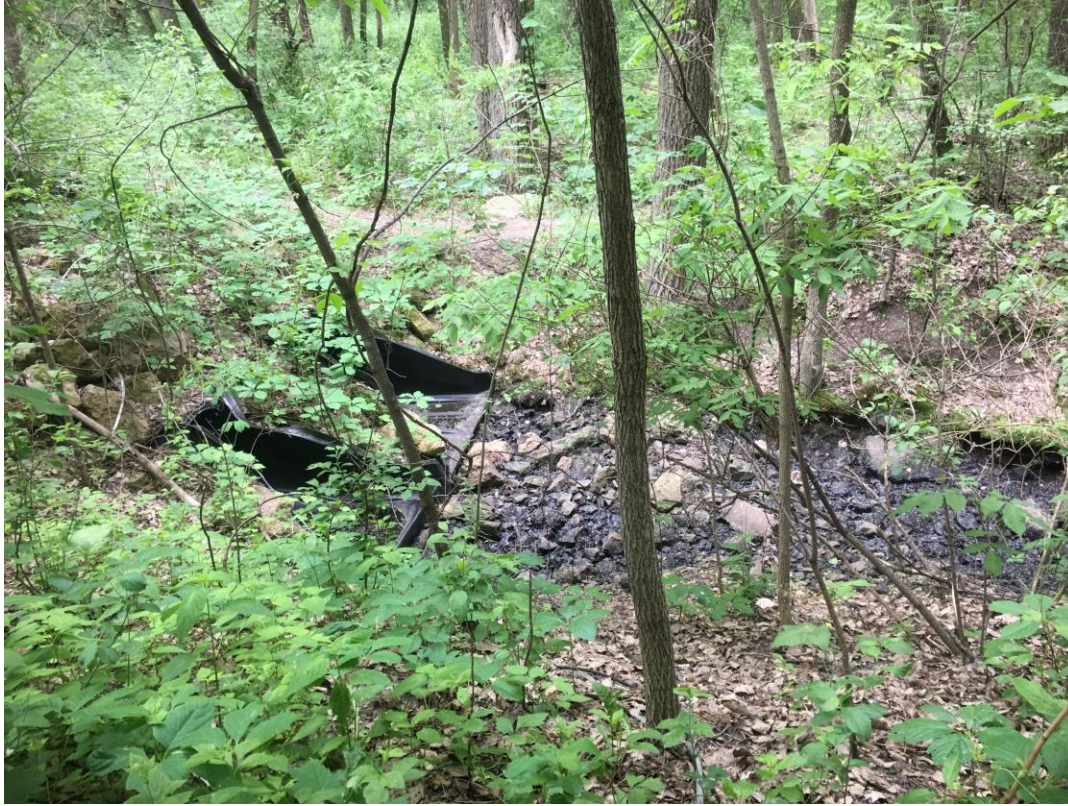
# SR4 – South Rice site 4

Double culvert that is dry until rain events

- Flows into South Rice
- Highest average TP and SRP concentrations of the sites
- Low flow since only during storm events
  - $0.05 \times 10^6 \text{ m}^3$
- Average nutrient loading
  - TP: 30 lbs/yr
  - TN: 213 lbs/yr
  - TSS: 3,900 lbs/yr
  - Chlorides: 577 lbs/yr

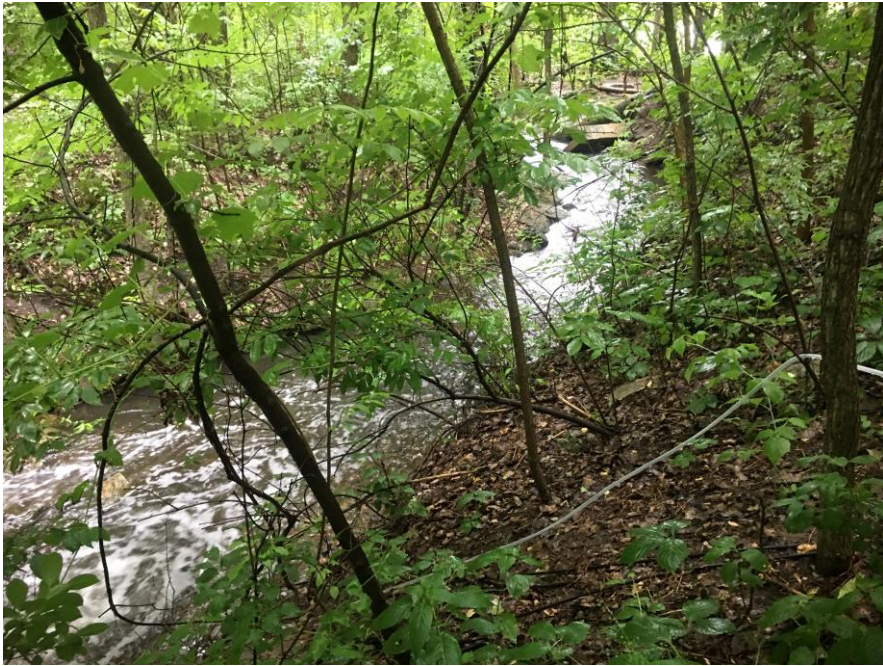
Downstream of site

- Quite a bit of concrete and building materials
- Channel is eroded due to heavy flow through this area

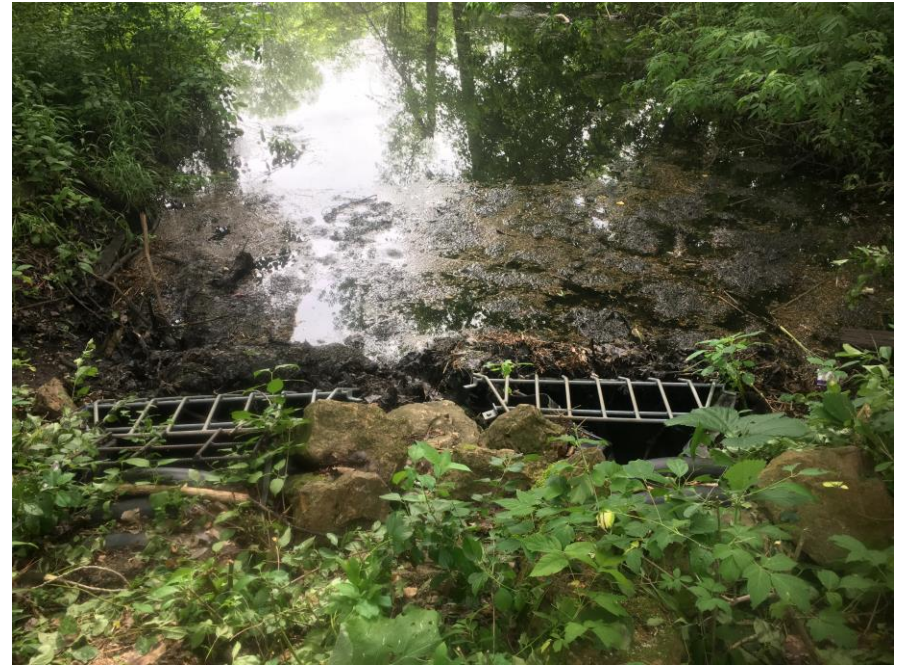
Upstream side of culvert

- Grates collect a lot of detritus/debris that is high in nutrients

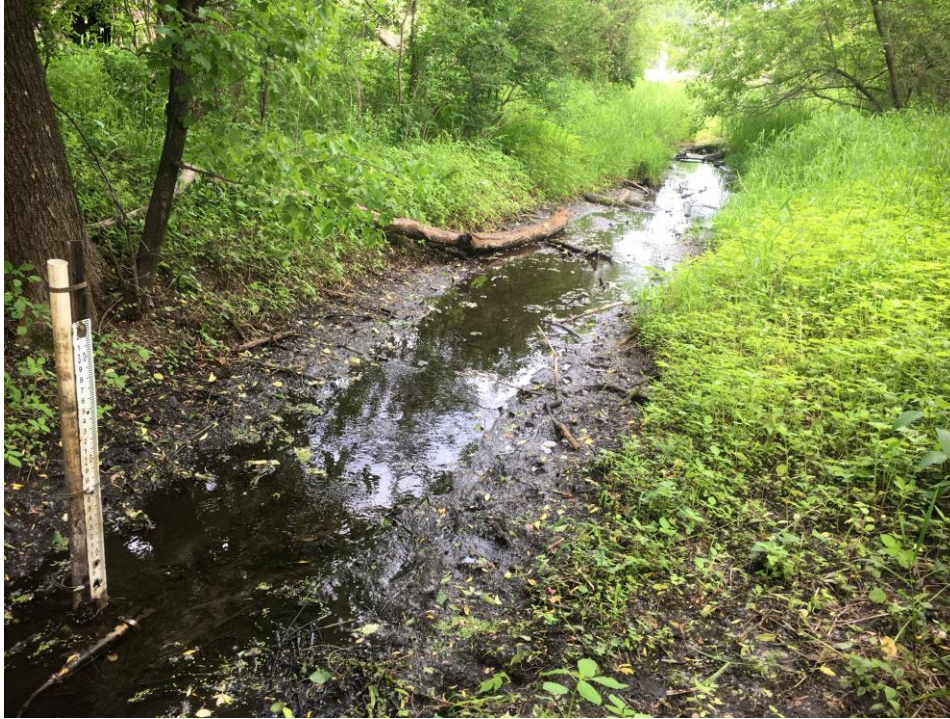
# SR5 – South Rice outlet

- Flows out of South Rice
  - There is a 2<sup>nd</sup> outlet channel with similar flows
- Average concentrations
- Measured flow is comparable to flow into South Rice
  - $0.13 \times 10^6 \text{ m}^3$
- Has highest loading of the sites except for chlorides
  - TP: 74 lbs/yr
  - TN: 526 lbs/yr
  - TSS: 9,300 lbs/yr
  - Chlorides: 28,700 lbs/yr
